Analysis of Road Traffic Accidents on NH45, Kanchipuram District (Tamil Nadu, India)

Ravishankar Rajaraman
INDIA, JP Research, ravishankar@jpresearch.com

With the support and cooperation of the Kanchipuram district police and Tamil Nadu police, researchers conducted detailed investigations of accidents occurring on the National Highway 45 over a 60 km stretch. The primary objective was to collect and analyze India-based traffic crash data to begin to create a sound basis for decision making for improving safety on India's roadways. A secondary objective was to establish a standardized methodology for collecting and analyzing crash data, specific to Indian roads. For the 45 day study period, an accident intimation network was established between researchers and all police stations/highway patrols in the study area. On occurrence of an accident, police called a 24-hour contact number and researchers responded to the scene. On site, researchers used standardized reporting forms, methodologies, and equipment to perform accident scene examinations, accident vehicle examination, and AIS injury coding. The collected accident data was categorized first by single- or multiple-vehicle cras

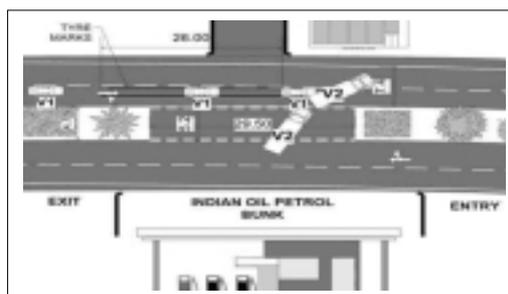
Figure 1A: Accident Scene Diagram

Figure 1A shows the diagram of an accident scene. The truck V2, which had stopped at the petrol station on the other side for refueling, exited the petrol station to join back onto the other side of highway. The car V1, approaching the intersection, braked and skidded for a distance before hitting the rear left wheel of the truck V2. Photographs of the scene showing the direction of approach and travel are given in figures 1B and 1C.

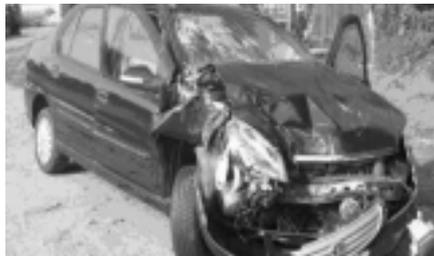
01 = Principal Direction of Force (1 o'clock direction)

F = Type of Impact (Frontal)

Z = Location of Damage (Right and centre of frontal area)

E = Vertical Location (Below lower end of windshield)

W = Type of Damage Distribution (Wide)

3 = Maximum Extent of Crush from front bumper to lower windshield on a scale from 1 to 5

Figure 2: Frontal impact damage to a sedan. CDC coded is 0 1 F Z E W 3.

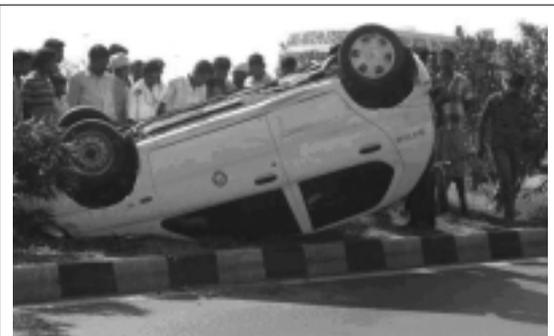
An example of injury coding and correlation is described below. Figures 3A, 3B and 3C show the exterior and interior parts of a car involved in a rollover accident examined under this study. Although the driver escaped uninjured, the front left occupant sustained injuries in the accident. The injury report for the front left occupant mentioned a head laceration. The AIS codes obtained for the injuries were as follows:

Figure 3A: Rollover Accident. Roof Crush measured is 18 cm and occupant contact identified.

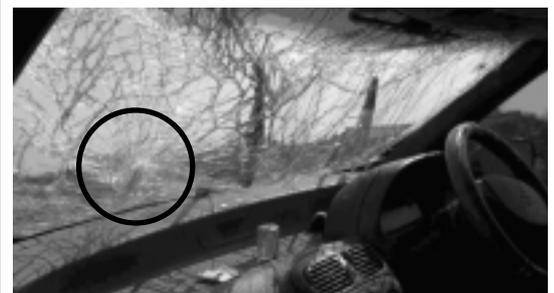
The occupant contact points in the car interiors, shown in figures 3B and 3C, were examined and then correlated with the injuries of the occupant to determine the cause of each injury. As can be seen the blood marks on the roof indicate injury on the head. On closer inspection of the windshield, blood marks were found giving the indication that the occupant's head hit the windshield, which caused the injury. Hence the source of the head laceration was determined as windshield. This also indicates that the occupant was not wearing seatbelts, and the same was confirmed on checking the seatbelts as they too had no marks on them to indicate usage.

Figure 3B: Head contact with windshield.

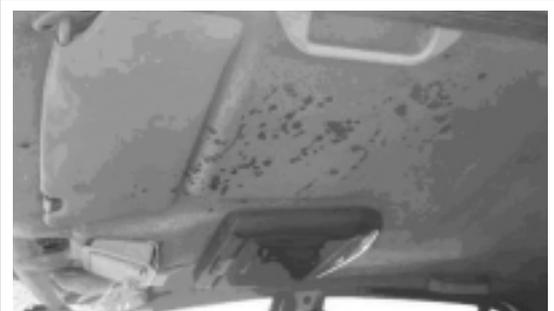
Figure 3C: Occupant contact points.

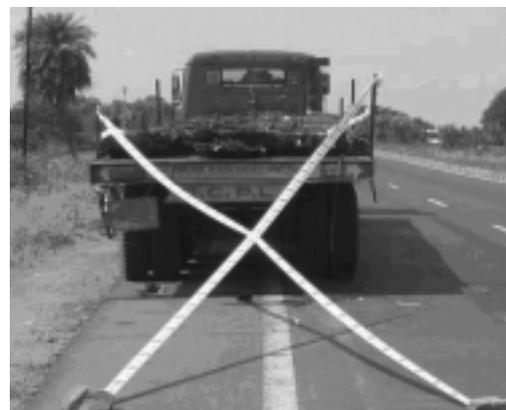
1. At many places on the highway, it was observed that sufficient space was not available for parking vehicles well outside the carriageway. Hence, in case of an emergency or break-down, trucks were often parked such that part of the truck intruded into the carriageway. As per specifications [5] the shoulder should be paved for 1.5 m and should be earthen ground for 3 m. But it was observed that the earthen ground was not suitable or sufficient enough for parking heavy trucks, as can be seen in figure 18.
2. It was also observed that entrances and exits to truck lay bys, gas stations and restaurants did not have a separate acceleration/deceleration lane, and in many cases lacked sufficient warning/information signs. This causes vehicles to immediately slow down or stop on arriving at a facility and this results in front-rear collisions with vehicles travelling behind them.

Figure 18: The shoulder width is not sufficient for parking heavy trucks.

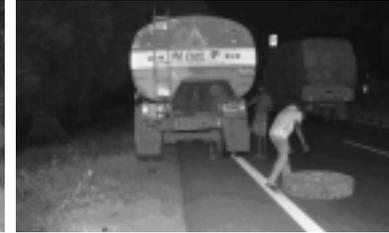
- Two of the front-rear collisions involving stopped vehicles took place at merging lanes. There were no warning/information signs and also the lane merging distance was found to be too short, as can be seen in figure 19.
- Adequate signs about restaurants, rest areas, gas stations, service centers, etc., posted well in advance, may help motorists make better decisions and avoid sudden stopping or slowing down.

Figure 19: No deceleration lane or sign post at the entrance to a truck lay by.
