Analysis of Road Traffic Accidents on NH45, Kanchipuram District (Tamil Nadu, India)

Ravishankar Rajaraman
INDIA, JP Research, ravishankar@jpresearch.com

With the support and cooperation of the Kanchipuram district police and Tamil Nadu police, researchers conducted detailed investigations of accidents occurring on the National Highway 45 over a 60 km stretch. The primary objective was to collect and analyze India-based traffic crash data to begin to create a sound basis for decision making for improving safety on India's roadways. A secondary objective was to establish a standardized methodology for collecting and analyzing crash data, specific to Indian roads. For the 45 day study period, an accident intimation network was established between researchers and all police stations/highway patrols in the study area. On occurrence of an accident, police called a 24-hour contact number and researchers responded to the scene. On site, researchers used standardized reporting forms, methodologies, and equipment to perform accident scene examinations, accident vehicle examination, and AIS injury coding. The collected accident data was categorized first by single- or multiple-vehicle cras

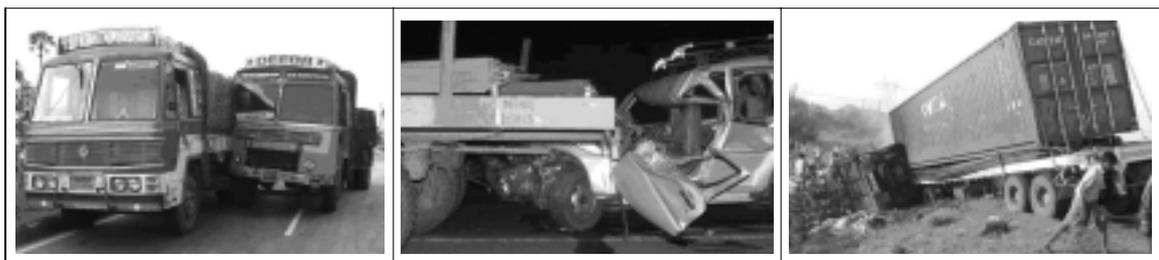
Figure 9: Examples of front-rear collisions.

1. Of the two vehicles involved, one is a "leading" vehicle while the other is a "following" vehicle.
2. The "leading" vehicle suffers either a rear impact (13 out of 19) or a side impact (6 out of 19), while the "following" vehicle suffers a frontal impact.
3. Occupants of the "leading" vehicle usually suffer no or minor injuries, while those of the "following" vehicle have a greater tendency to suffer severe injuries.

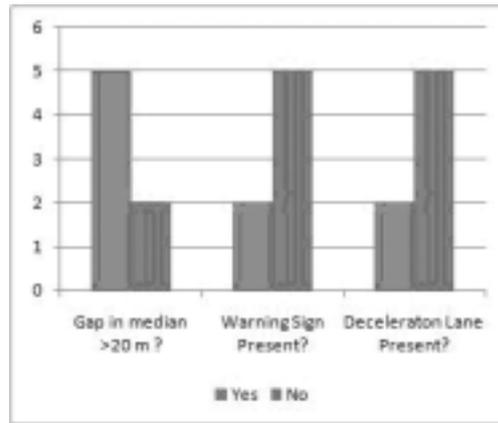
Figure 16: U-turn standards and specification compliance.

Researchers then coded each of the 7 U-Turn locations near which the 8 Front-Rear Collisions took place (one of the U-Turn locations witnessed two separate accidents) to determine if the specifications laid down [4] are being followed. Figure 16 shows the results of the analysis. The absence of warning signs and, most importantly, deceleration lanes, clearly indicate that:

1. Drivers are not being fore-warned of approaching U-turns.
2. Vehicles in the high speed lane which need to use the U-turn, necessarily have to slowdown, hence increasing the chances of vehicles following them to rear end.

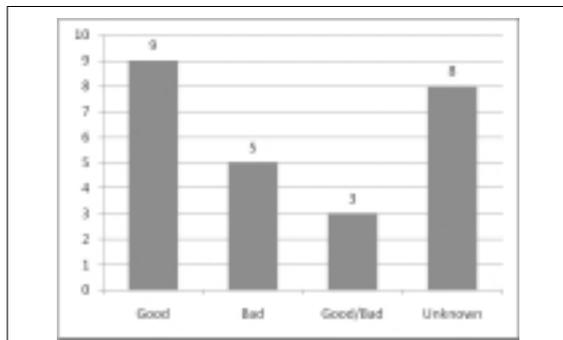
Figure 24: Tire conditions of heavy trucks examined.

A visual inspection was conducted for all the tires to determine if the tread depth was sufficient for better handling of the vehicle and if there was any damage to the tires. If for all the tires, the tread depth looked sufficient and the tires were undamaged, a good rating was given. If none of the tires had sufficient tread depths or had damage, a bad rating was given. If some tires were good and some bad, a good/bad rating was given. For this study, it was found that nine of the trucks had good tires. However, 5 of them were rated bad and 3 were good/bad. The tire condition was unknown for 8 of the vehicles. It can thus be noted that only about half of the number of vehicles examined had all good tires, while for the rest, at least one of the tires was not in good condition. Visibility to the rear of a truck is another area where there was not the level of standards seen in the real world that are required by existing laws. Rear visibility is achieved by having functioning tail-lamps and reflectors so that trucks are able to be seen from the rear during night time. In this study only 13 of the vehicles were found to have reflective markings on the rear of the vehicle, 9 did not have any reflectors and in three of the cases it was not known. 17 of the vehicles studied were equipped with tail-lamps; however they were non-functional on one of them. There were no tail-lamps for 5 of the vehicles. Both of these safety features are required by law and the fact that many of the vehicles are not complying with these laws is troubling.

As per Rule 95 of the Central Motor Vehicles Rules (CMVR) 1989 [6], all motor vehicles need to have their tires in good condition with sufficient tread depth. Rule 102 in the CMVR mandates that all trucks have functioning tail-lamps while Rule 104 requires all trucks to have rear reflectors. In this study it was quite evident that the rules were not being followed. This is an area where the enforcement of existing rules could be made more effective through more vigilant vehicle inspections.

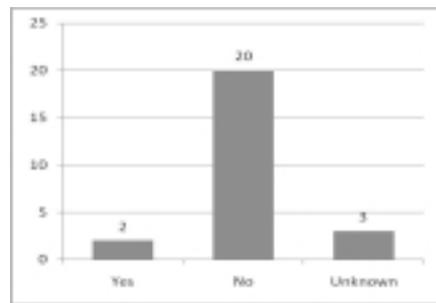
Figure 28: Underride protection presence.

Underride protection is an important area for truck safety when they interact with smaller vehicles. Because a bumper on a truck is much higher than that of a passenger car or jeep, it is imperative that trucks have underride guards. If a vehicle rear-ends a truck which has no underride protection, it is likely that the vehicle enters into the rear overhang of the truck and will sustain the impact with its A-pillars rather than the bumper, which is an area where the vehicle is not engineered to absorb the impact. This is especially important since it has been established in this study that most trucks were rear ended more than they were rear-ending other vehicles. Only two of the vehicles involved in this study had underride protection while 20 of the vehicles did not have any underride protection. For three of the vehicles, underride protection was unknown. Although it is required by Rule 124 of the CMVR for trucks to have underride protection, this rule only went into effect in 2003 so as more post-2003 vehicles are on the road, hopefully there will be more vehicles equipped with underride protection.

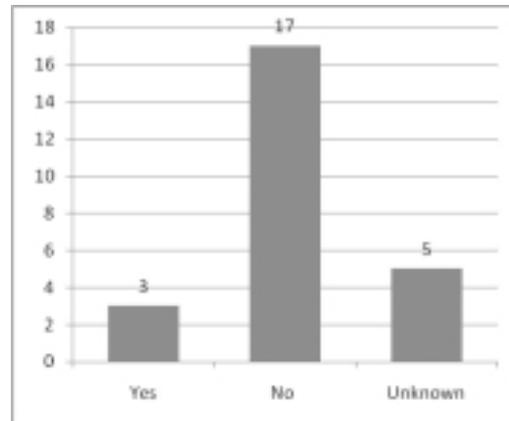
Figure 29: Seat belts availability

When conducting the interior vehicle inspection, researchers also noted if a seat belt was present in the truck and whether or not it was used. In this study there were no instances of belt use among the truck drivers. However, this could be seen as a symptom of a bigger problem because 17 of the vehicles inspected were not equipped with a seat belt while only three of the vehicles were equipped with them. In 5 of the cases it was unknown whether a belt was present. The fact that the overwhelming majority of trucks are not equipped with seat belts is a serious safety problem. Seat belts are by far the cheapest and most effective piece of safety equipment available for trucks, but without them as a standard piece of equipment, it is impossible for them to be utilized.
